Activity Report
Mass Rescue Operation Exercise
MS GANN February 10th 2020

Terje Brinck Løyning
Maritimt Forum Nord

Morten Nyheim Jørgensen
Maritimt Forum Nord

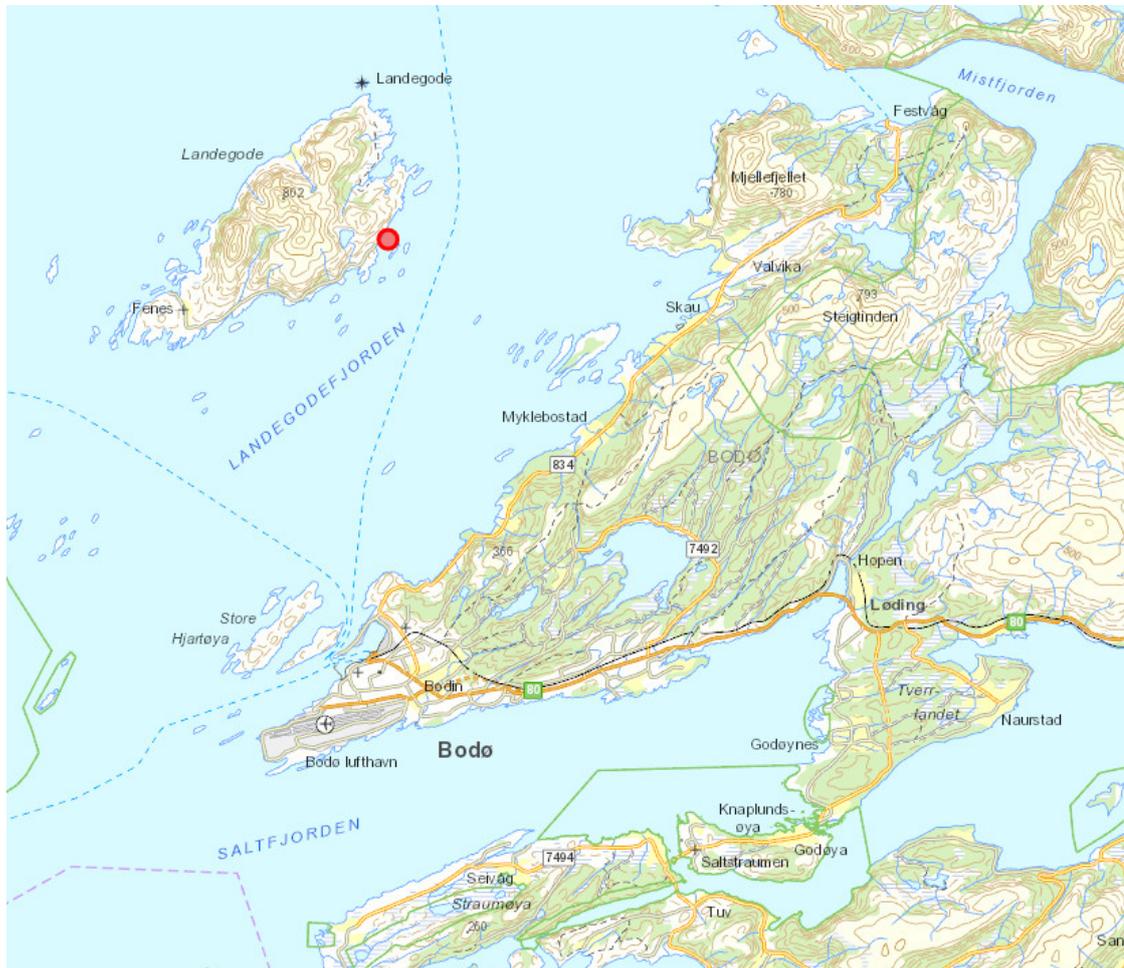
Figure 1.2: Topographical map of the exercise area.

The figs 1.2 and 1.3 shows the planned exercise location outside the city of Bodø, on a topographic map and on a nautical chart, respectively.

The embarking and the reception of personnel on the ship went according to the planned timings described in table 1.5 and we anchored on time in the intended position. There had been some concerns about the weather conditions, as the weather forecast for the day was not favourable at the location chosen for the exercise. We discussed some alternative positions, but the weather situation became better than the estimates, and we anchored in the area as planned, showed in figures 1.3 and 1.2.

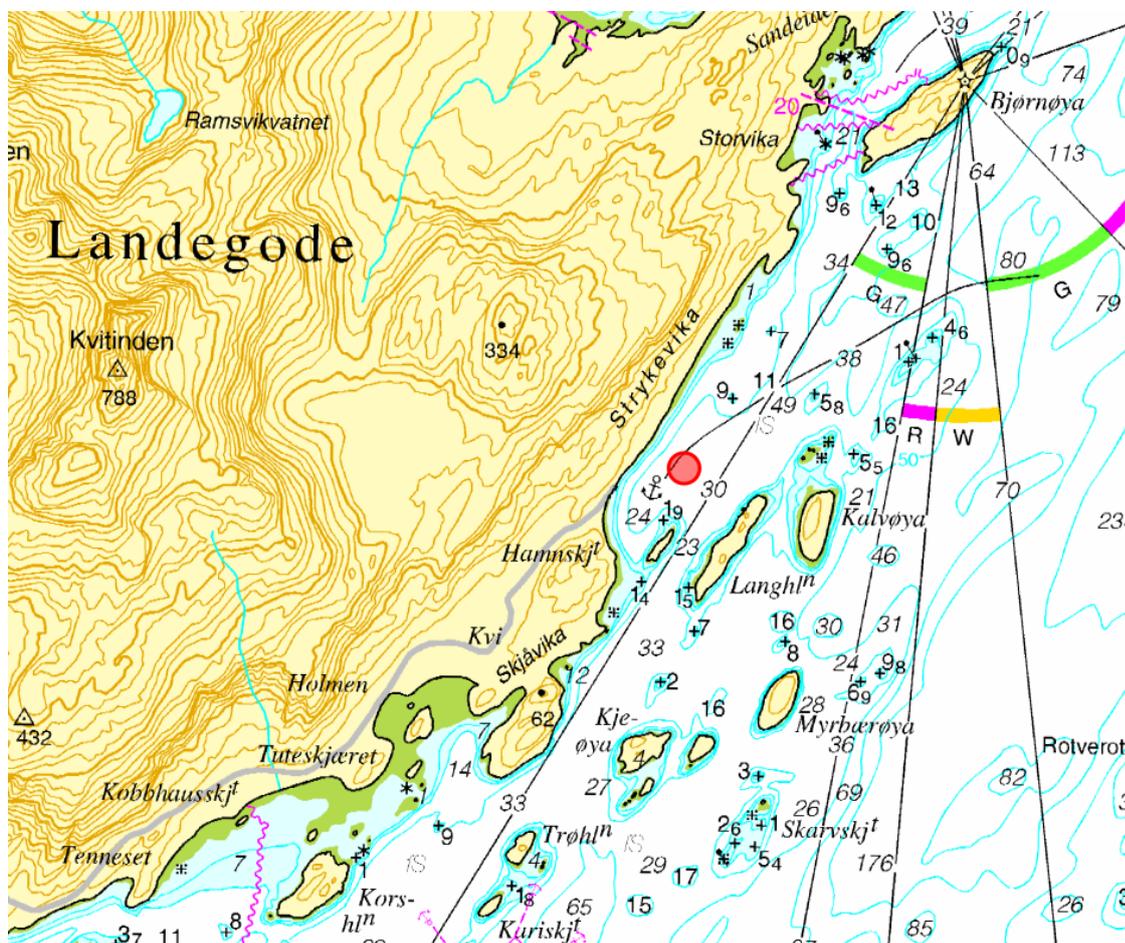
Figure 1.3: Nautical chart of the exercise area.

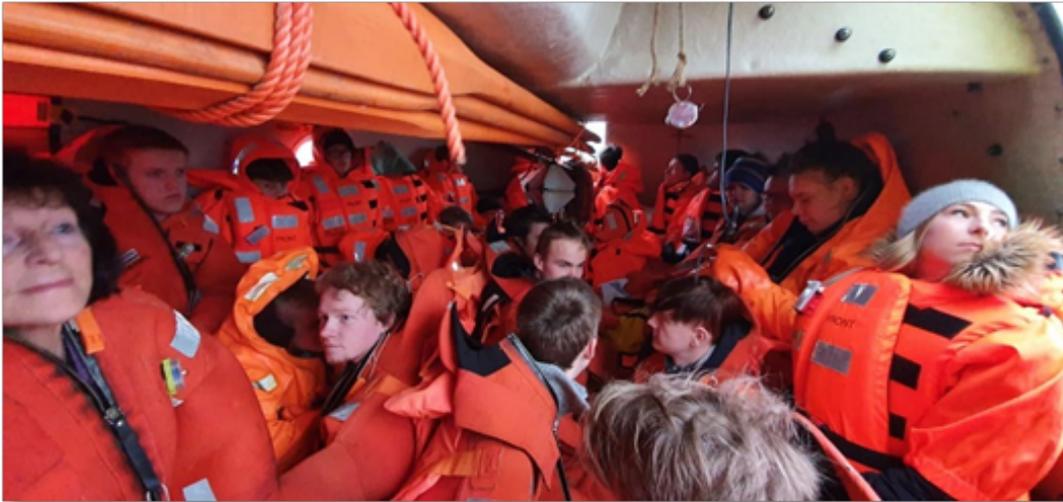
Figure 2.2: A lifeboat filled with personnel in their thermal protective suits.

This activity started after lunch, and all actors entered the lifeboats from a gate close to the waterline. In addition to the two boats, we filled a life raft with a certified capacity of 20 persons. Sixteen persons filled the raft, sitting shoulder by shoulder and their feet directed towards the centre of the raft. The remaining four persons had no other option than to take place in the centre of the raft, but this arrangement would have made it difficult for all to stretch their legs. We assessed that we could not fill the raft with the certified number of persons to comply with the polar code requirement of five days in a life raft. The situation on board that raft would have been insupportable within a short period.

The goal of this part of the process was to maintain the safety of the personnel. In a real situation, the crew would have launched the lifeboats from the upper deck with persons inside.

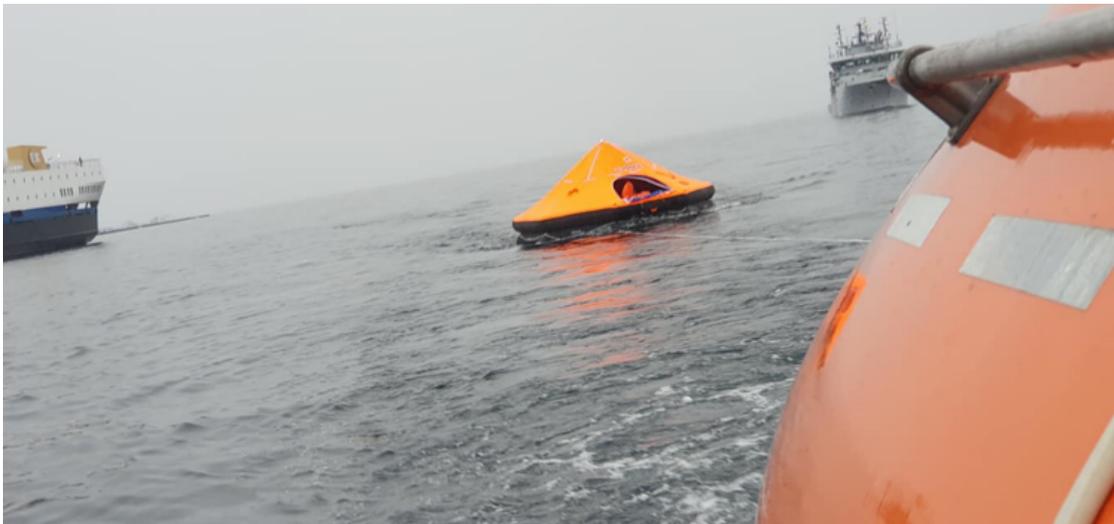
Figure 2.3: Navigation exercises, keeping the raft and life boats together.

When the lifeboats and the life raft were moving around, we began several tests and exercises with a focus on coordination. In one particular test, we instructed the navigator on one of the lifeboats in advance, to stop functioning (he played dead). This exercise intended to observe how long time it would take for the rest of the participants to reorganize and take control over the lifeboat. Another task was to keep the three floating units together, i.e. one of the boats would have to take control of the life raft since this unit did not have a propulsion system to navigate. The task was to take control of the life raft and tow it in a proper direction.

- The coordination and interaction between the lifeboats and the life raft worked splendidly. Excellent communication between the units, and favourable weather conditions, made the tasks easy.

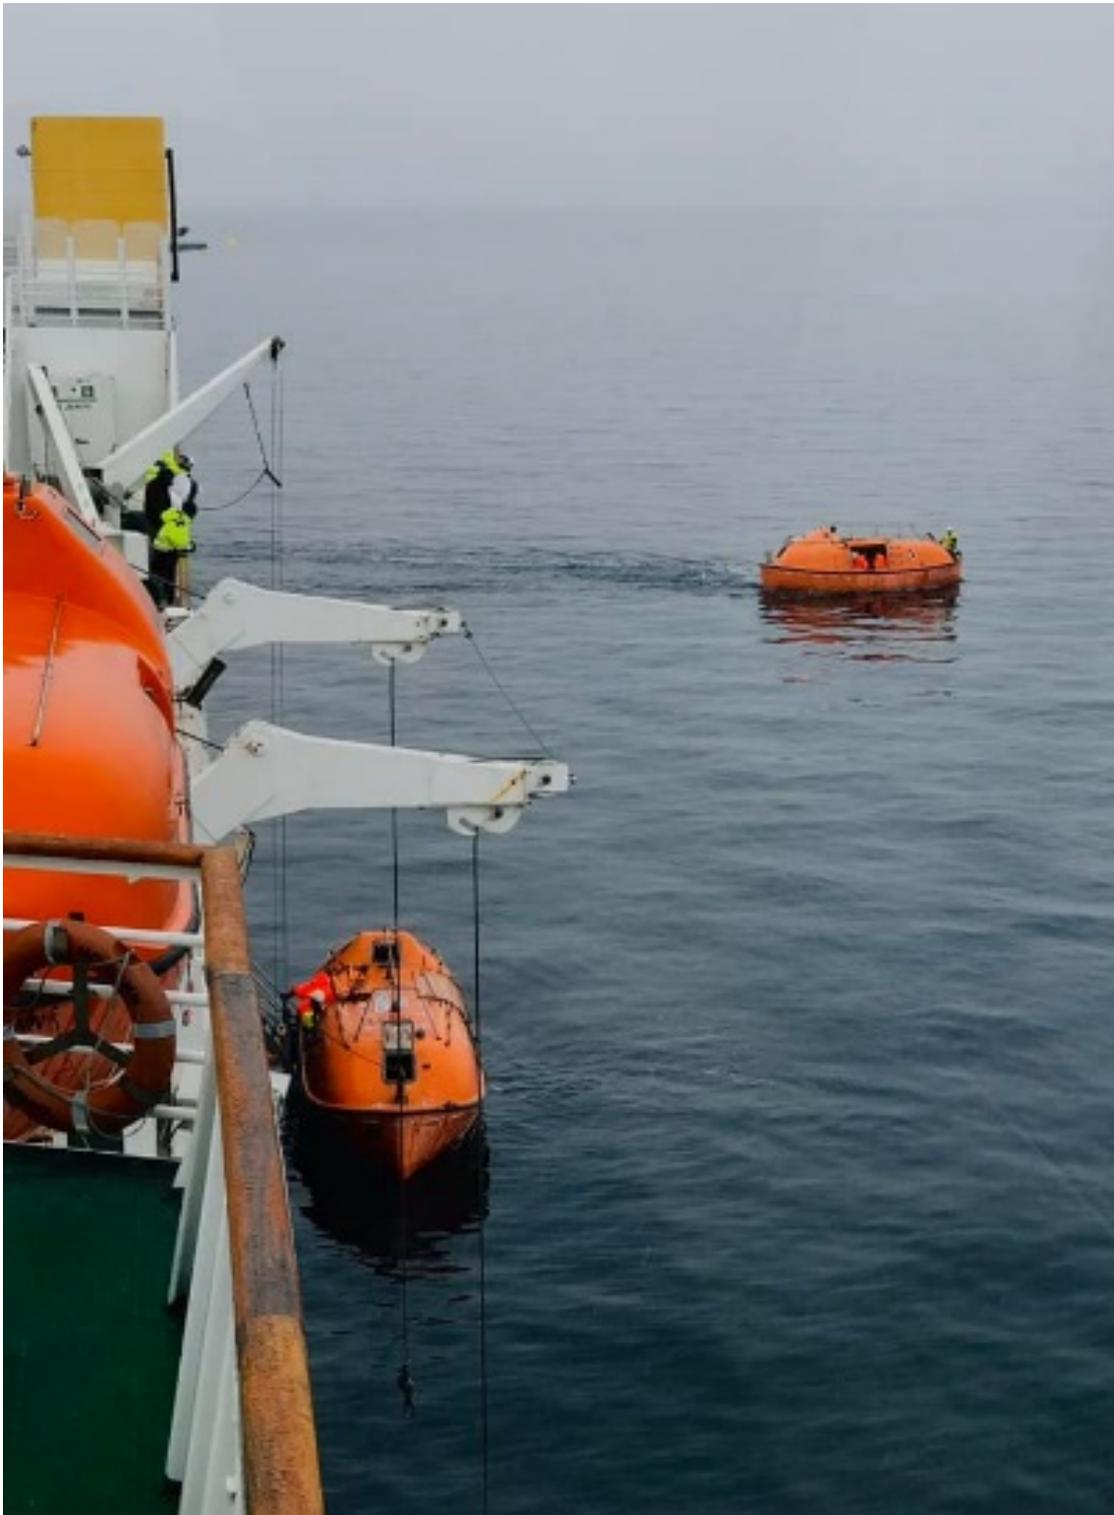
Figure 3.1: Both life boats on the water.

- The lifeboat was easy to manoeuvre when towing a life raft, and the transfer of the towing line was unproblematic. Again, the weather conditions may have affected this outcome.
